## Structural Assessment Report: Red oak (*Quercus rubra*)

**Location:** 29 Blackamore Ave  
Cranston, RI 02910

**Assessment Date:** May 30, 2025

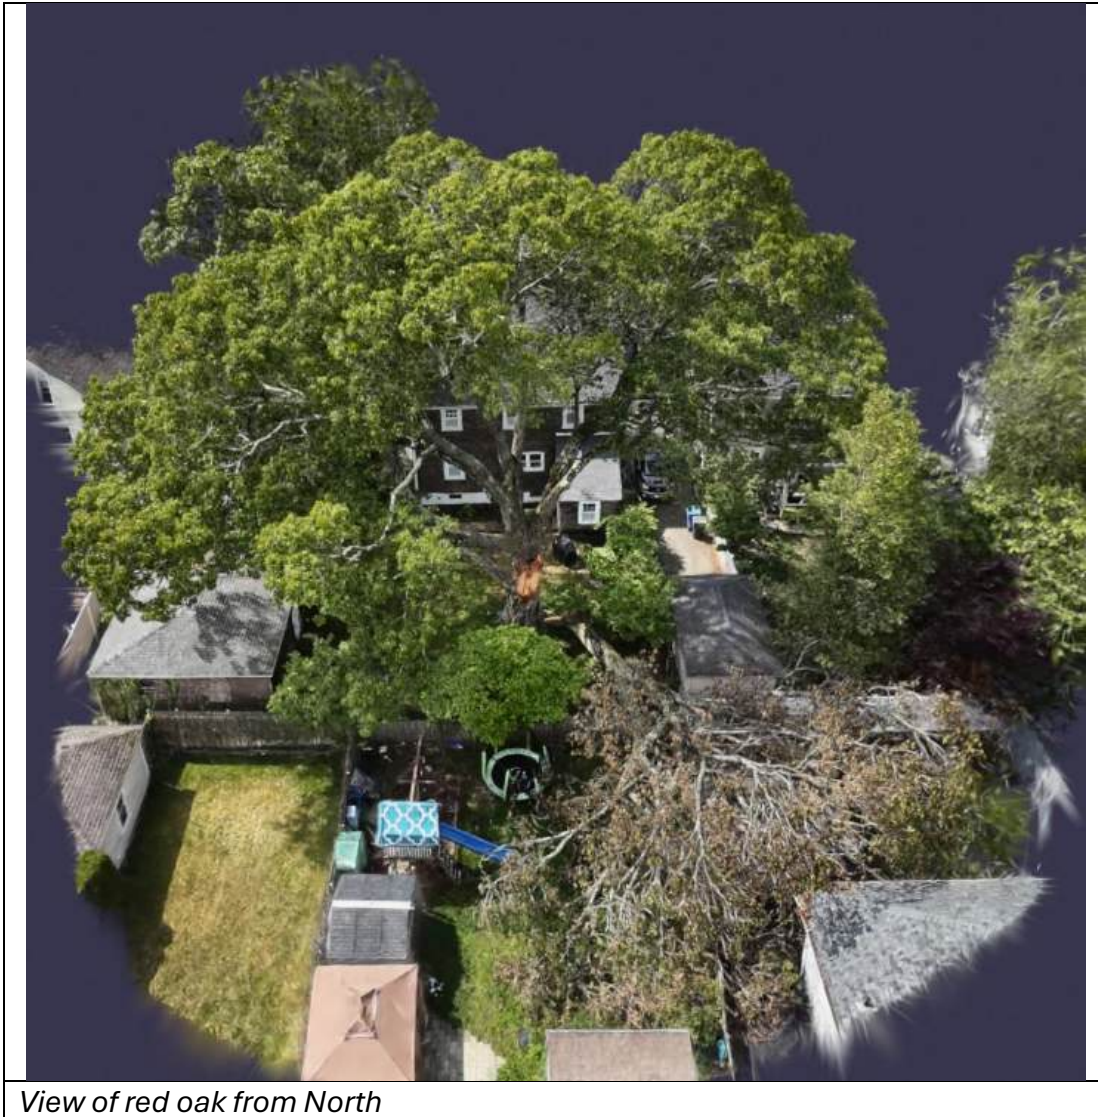
During the ground-level and aerial, drone-assisted inspections, the red oak was observed to be a large, mature, broad-spreading tree with an expansive canopy that dominates the residential landscape. The tree displays a classic open-grown form, with a very wide and rounded crown. The trunk is robust with a noticeable flare at the base, indicating a well-developed root system that anchors the tree. The tree has several massive, lateral scaffold limbs, extending in multiple directions. These leaders overhang houses, sheds, fences and driveways.

*View of red oak from North*

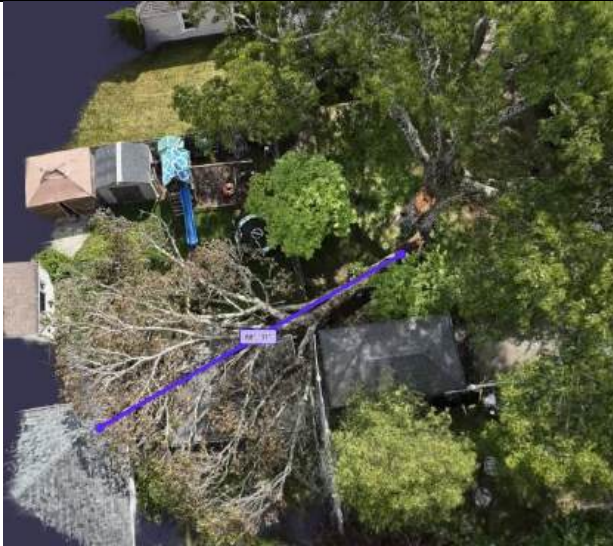
The failed leader was a major scaffold, about 60' (18 m) in length, which had formed a significant portion of the north side of the crown. The failure has left a large, open wound on the main trunk of the red oak. The wound extends approximately 8'7" (260 cm) vertically and 3'5" (104 cm) horizontally, exposing both sapwood and heartwood.

View from northwest

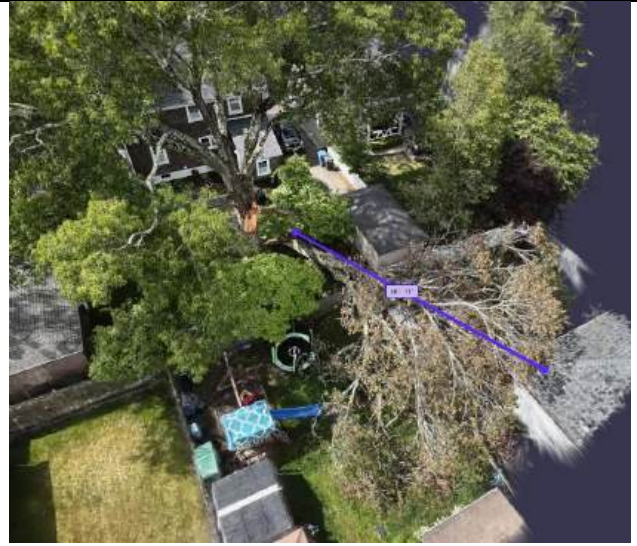
View from northeast

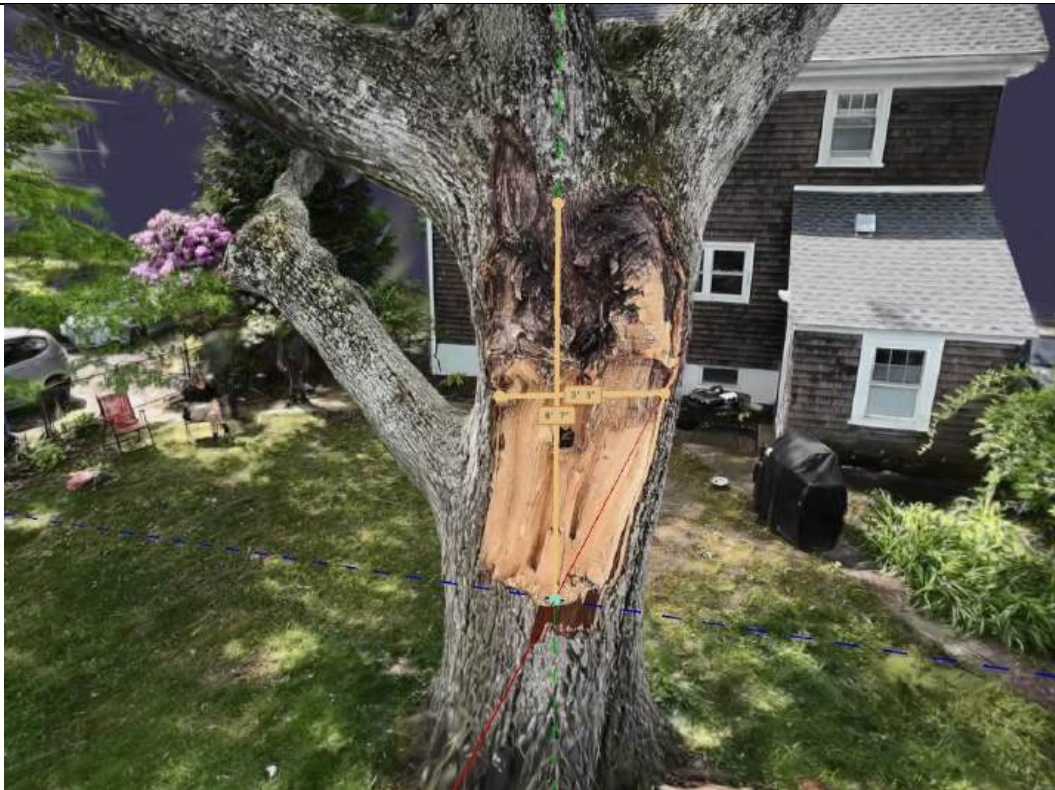
Wound measurements

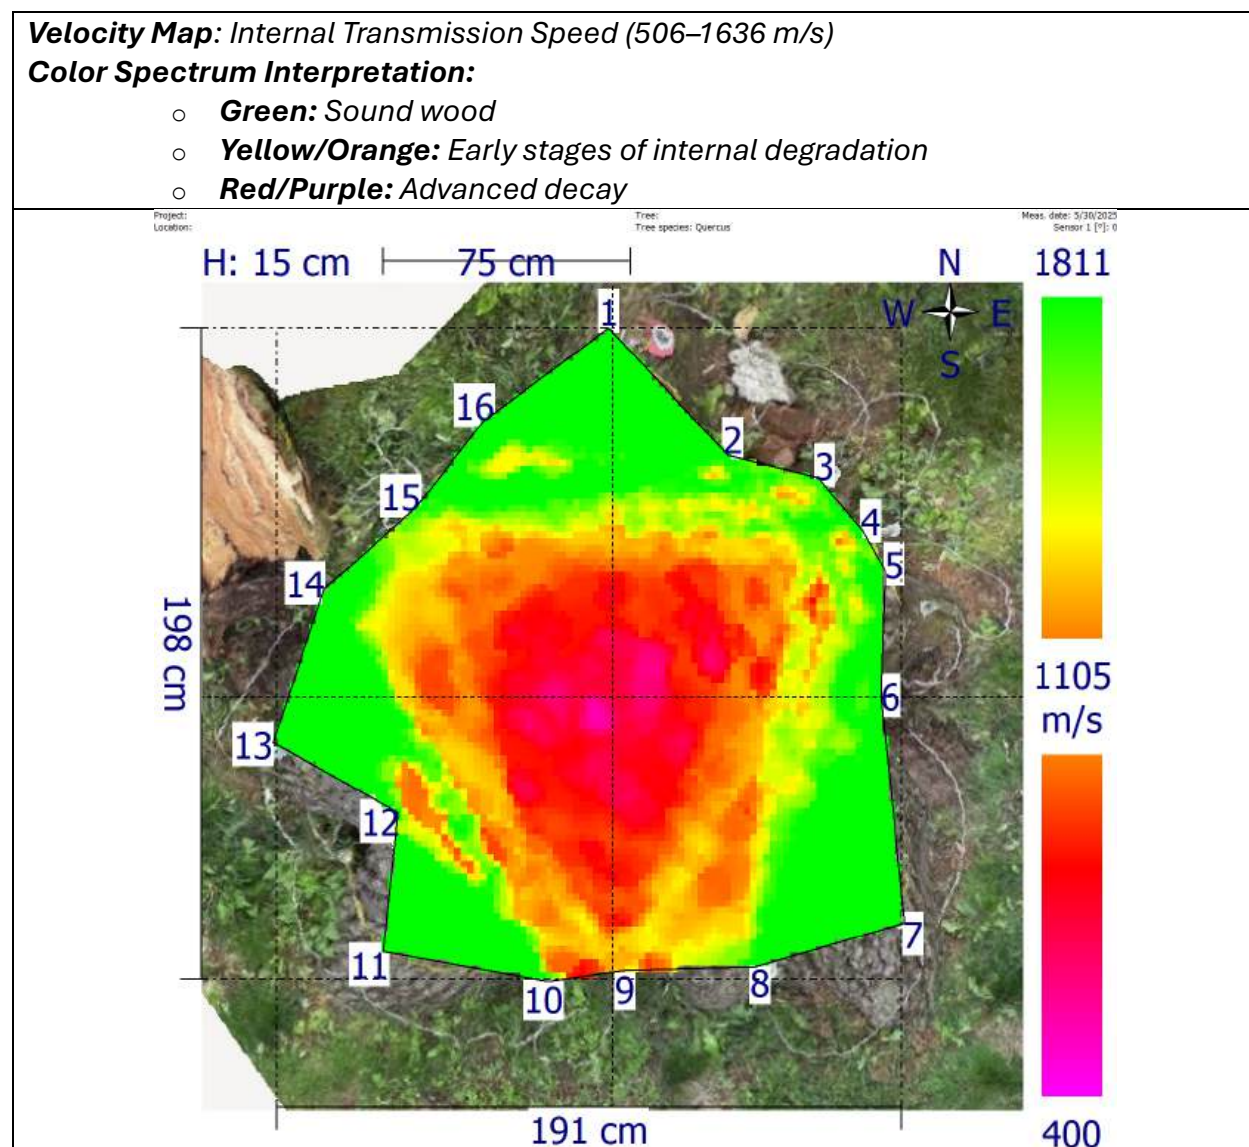
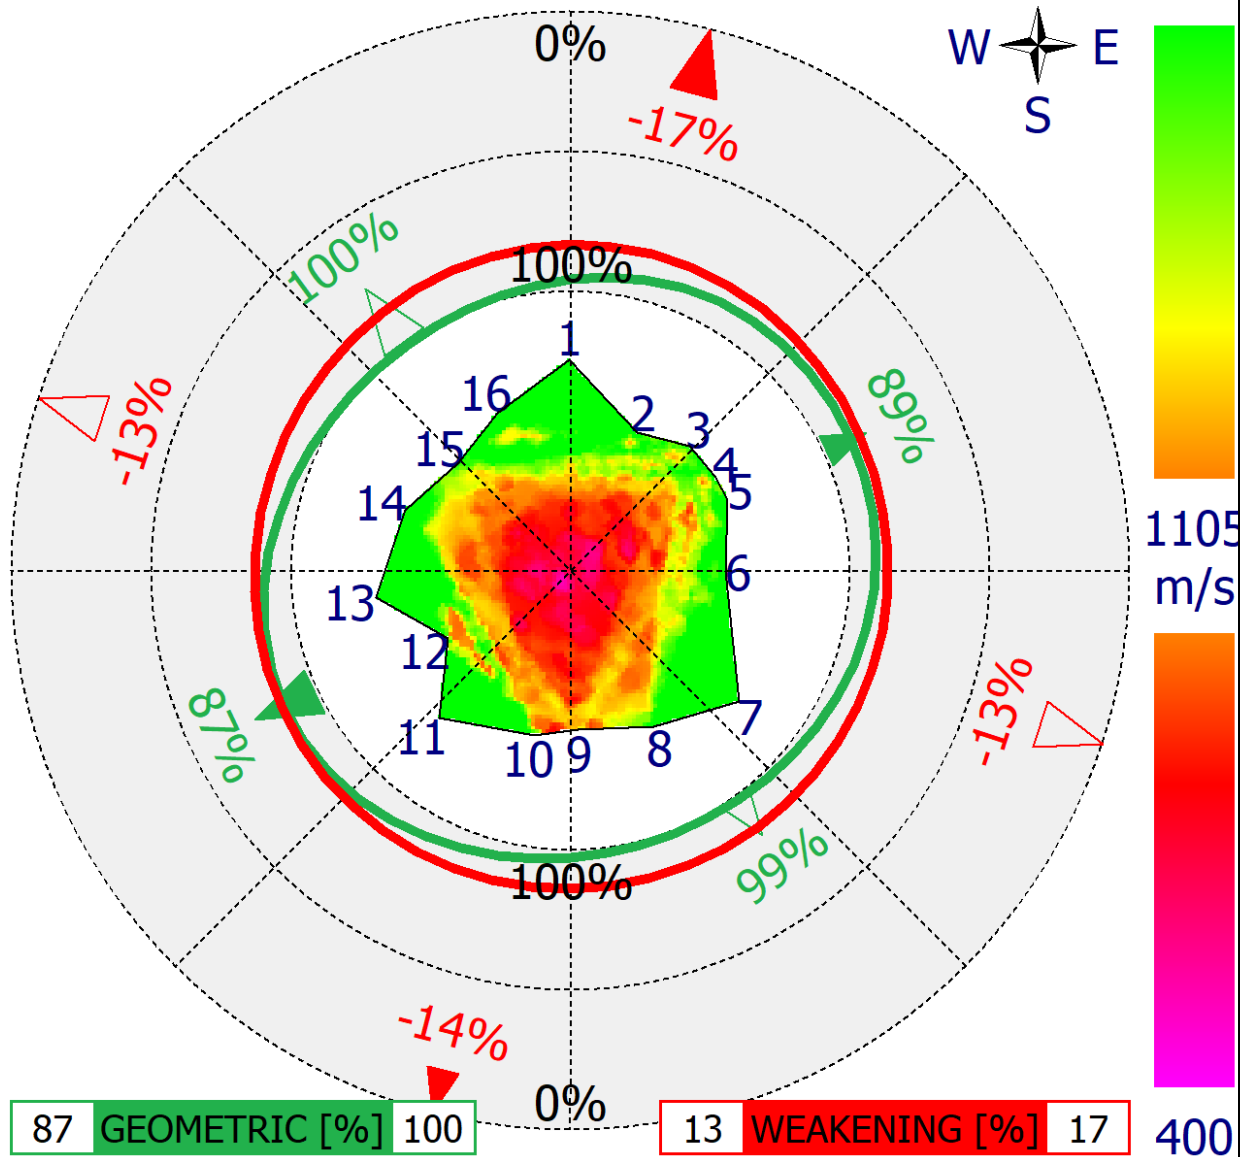
Our sonic tomography was conducted on the red oak at 15 cm above ground, with a trunk diameter of approximately 194 cm (76 inches). The tomography identifies a central heart-shaped area of decay that is approximately 50-60% of the cross-sectional area studied.

The remaining sound wood forms an uneven outer shell that appears sufficient to support the tree's structure under current loading. The shell wall varies in thickness from 30–40 cm (12–16 inches) in the strongest sectors, down to 15–20 cm (6–8 inches) in the thinnest sectors, notably on the south side of the trunk.

The area of decay reduces the tree's load-bearing capacity by approximately 13–17%. The greatest loss of strength is observed in the opposing northeast and southwest quadrants.

- Prune the canopy selectively, targeting a 25–30% reduction in crown area in accordance with ANSI A300 Pruning Standards. Pruning should prioritize maintaining structural symmetry to minimize torsional stresses and ensure balanced load distribution.
- Conduct annual visual inspections to monitor canopy regrowth, structural integrity, and potential hazards. Pay particular attention to the root flare for signs of decay or structural changes. Ongoing monitoring of the large trunk wound from the recent limb failure is critical to detect any progression of decay.
- Perform sonic tomography every 18–24 months to evaluate the condition of the remaining sound shell wall and track any internal decay progression.

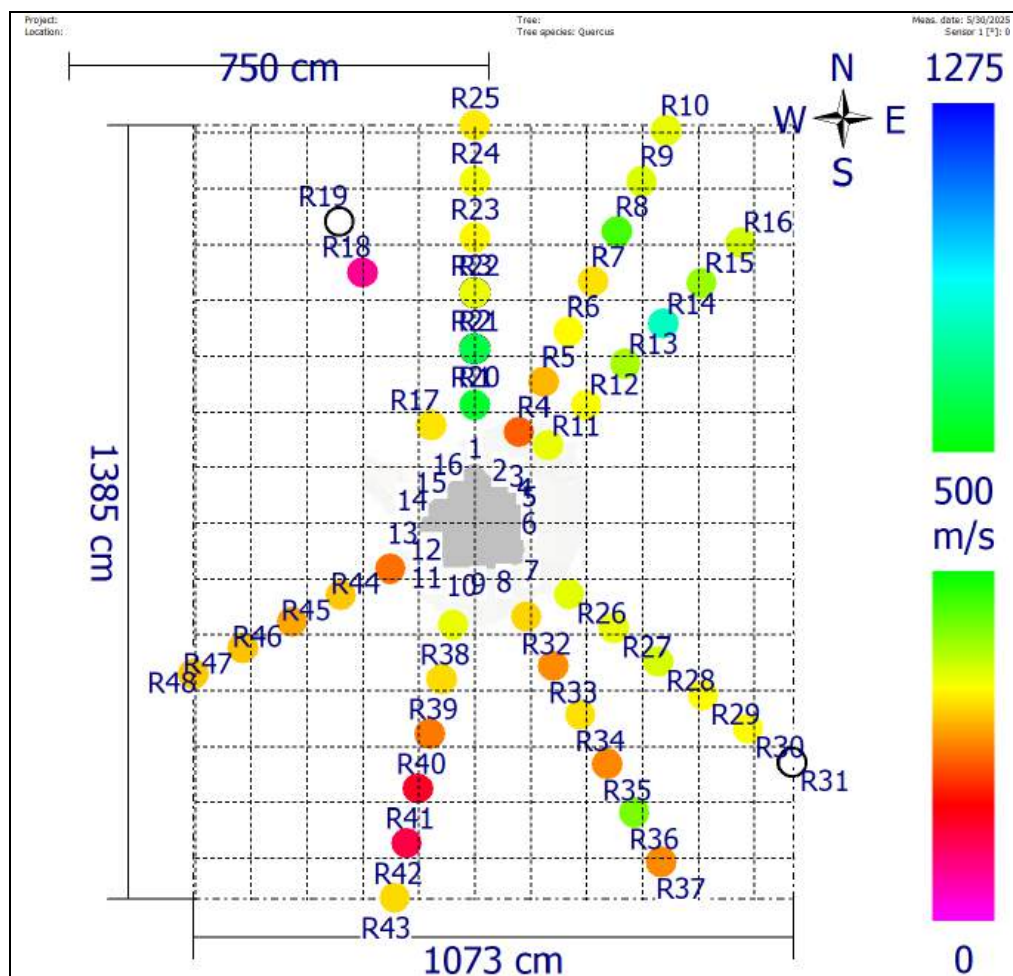
**Higher velocities (500–1275 m/s, green to blue):** Indicate healthy, intact root wood, seen in **most radial points** across the north, east, and central quadrants.

**Lower velocities (200–500 m/s, yellow to orange):** Observed in some isolated points (e.g., R40, R41) near **paved surfaces or compacted areas**—these readings likely reflect **soil conditions, paving, or voids** rather than true root decay.

- Specifically, points like **R40 and R41** were taken above a **paver patio**, where paving likely inhibits root growth or signal transmission, leading to lower measured velocities.

**No critical voids or major decay pockets** were detected across the measurement grid, supporting a **generally healthy root system**.

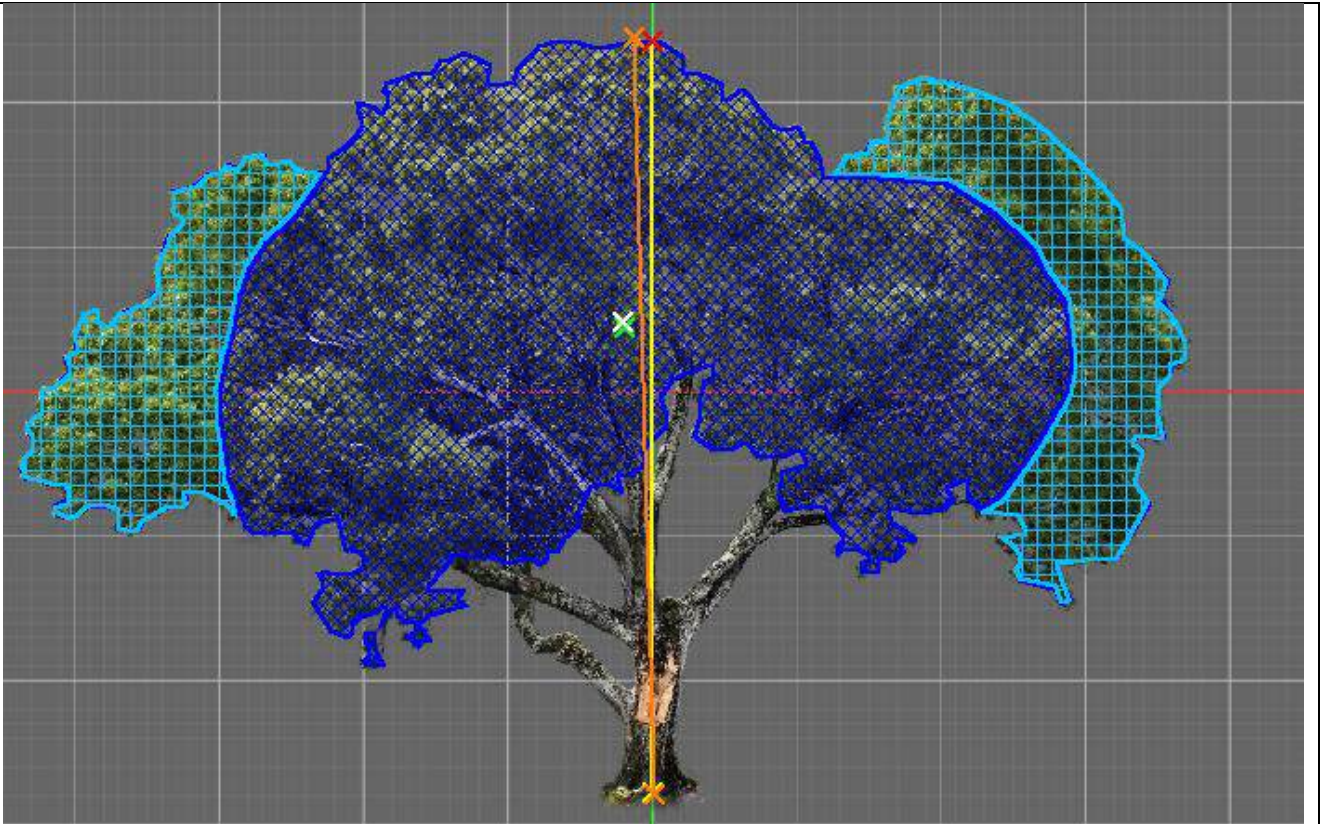
Wilkerson red oak 1

An image-based analysis was conducted to assess the crown sail area and overall exposure to wind forces. As seen from the north side of the tree, we created a pruning model to help support a management strategy of targeted pruning (approx. 25–30% crown area reduction) to reduce wind load while maintaining overall crown structure and height.
