## Structural Assessment Report: Red oak (*Quercus rubra*)

**Location:** 29 Blackamore Ave  
Cranston, RI 02910

**Assessment Date:** May 30, 2025

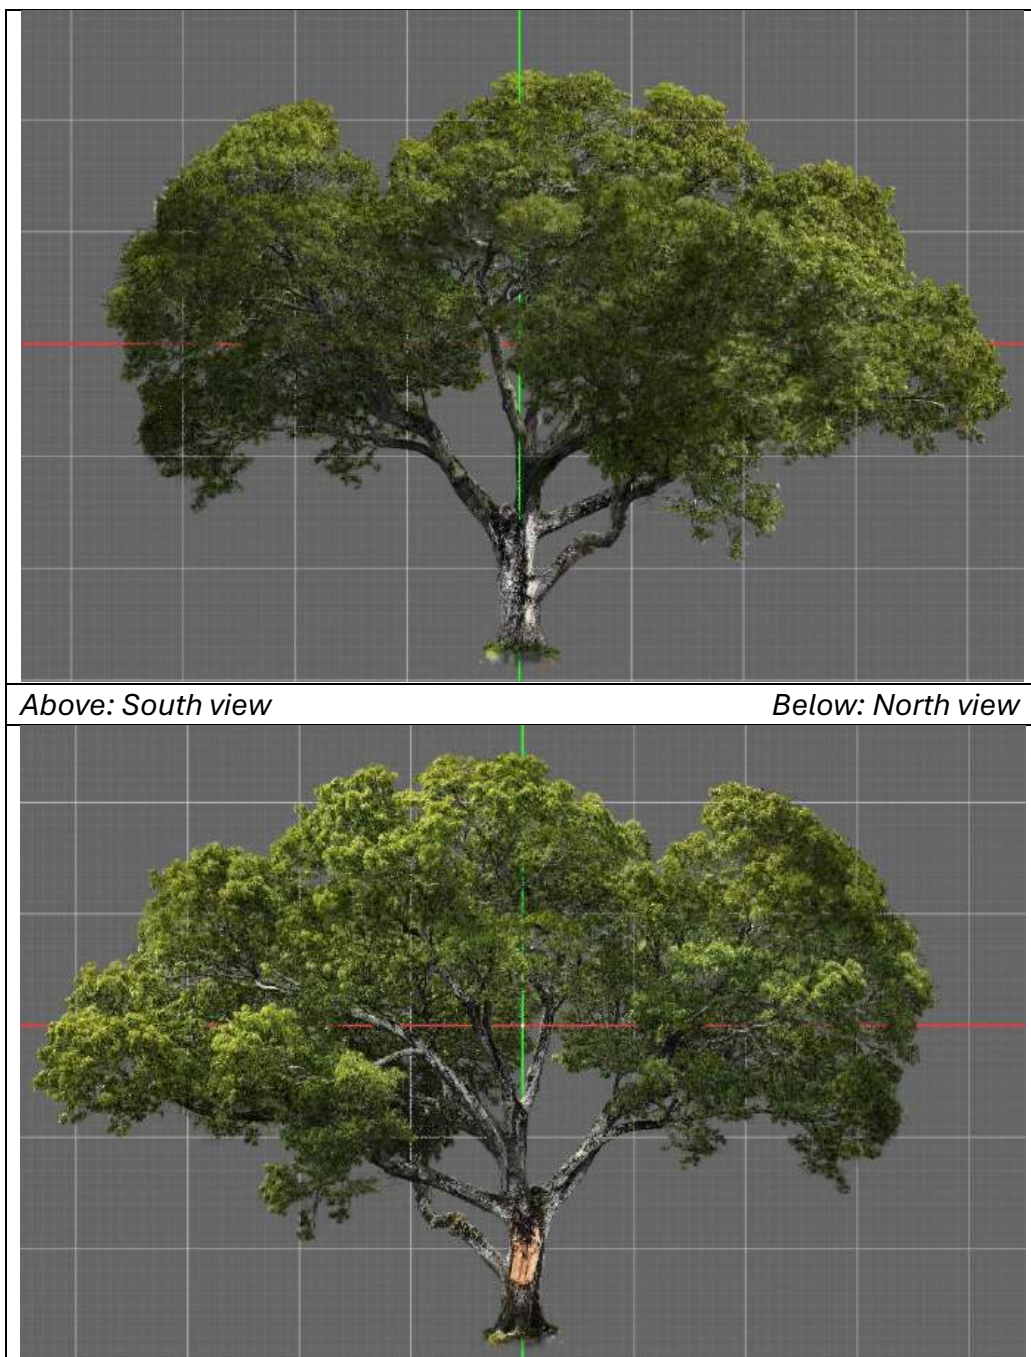
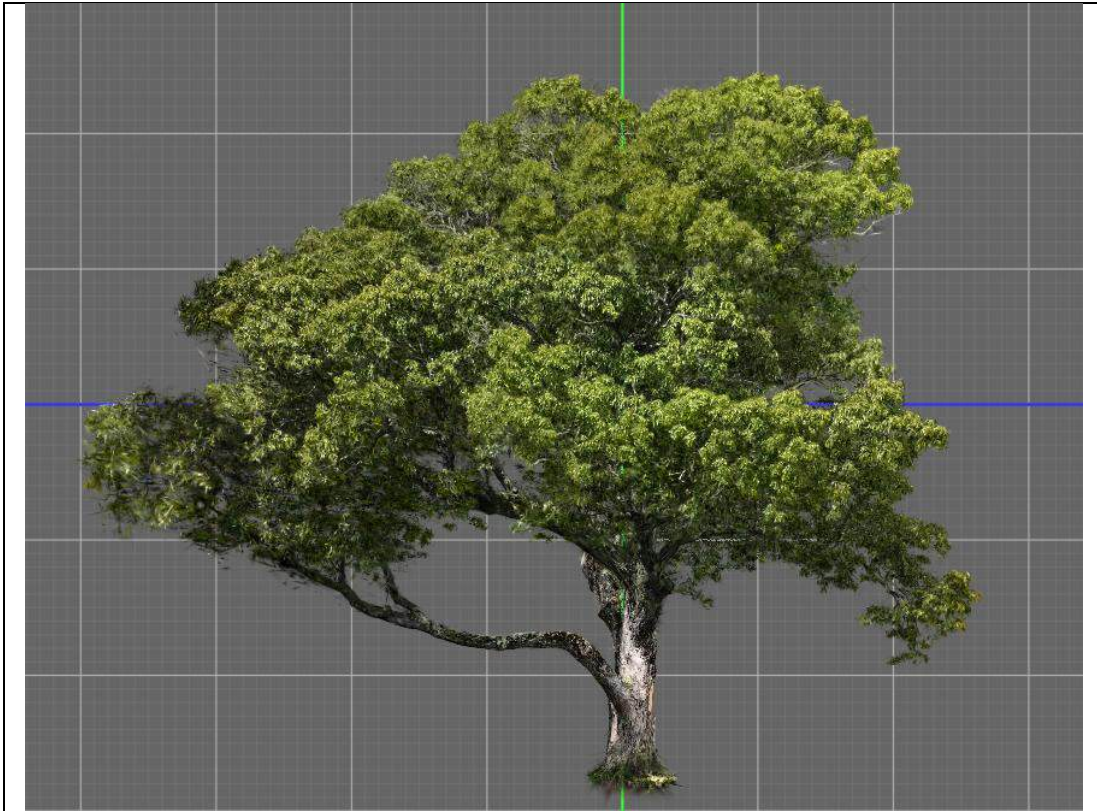
The oak's broad, heavy crown and large, extending scaffold limbs create significant leverage forces at the unions, particularly at the main stem. Wind exposure risk is high due to the expansive crown and the presence of large surface areas on multiple sides. The proximity of targets (houses, sheds, fences) increases the risk of property damage from future limb failures.

*Above: East view*

*Below: West view*

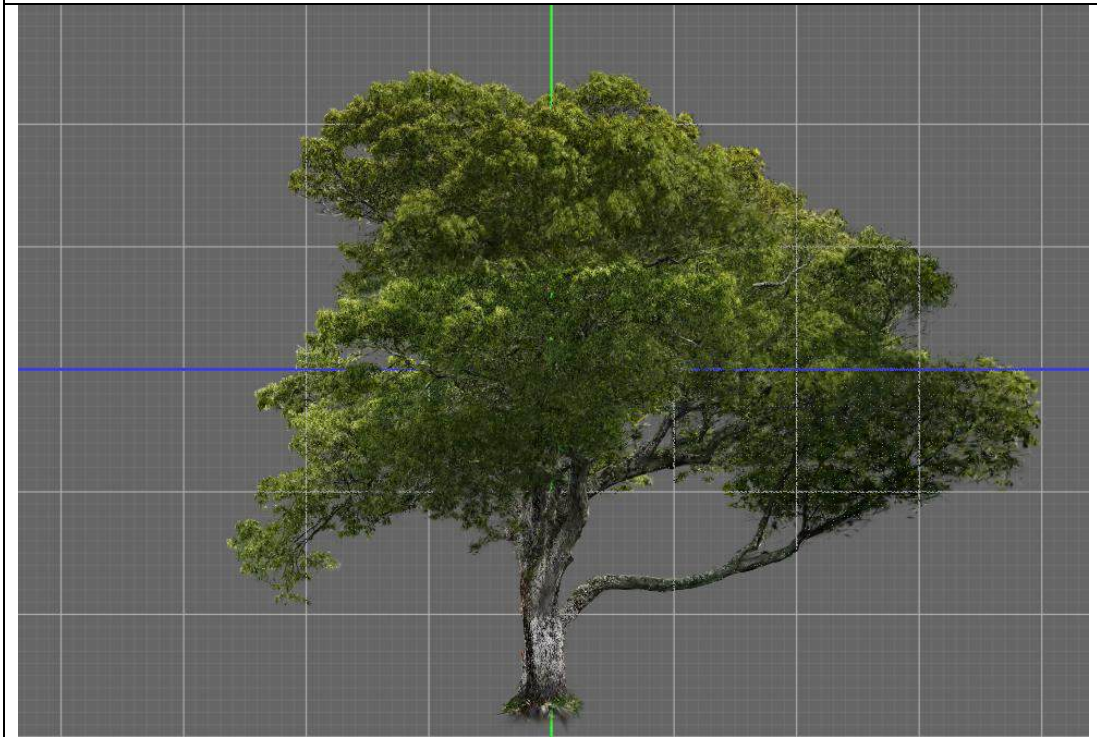
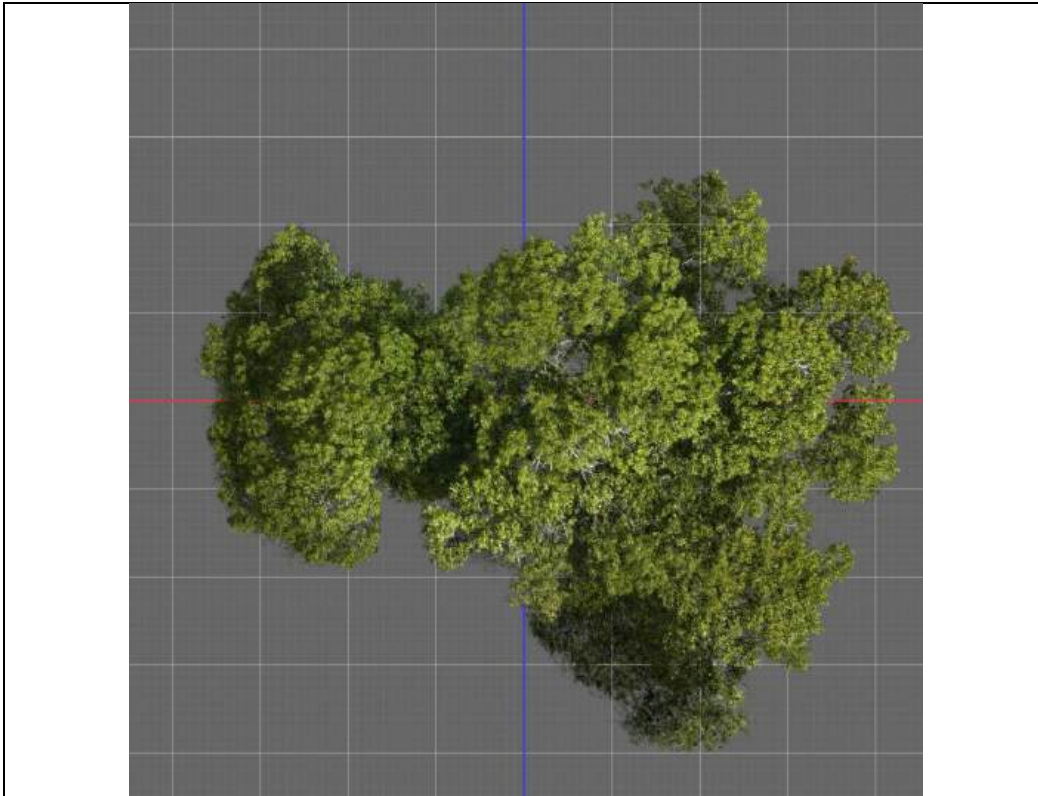
*Above: Top axis*

*Below: West view*
